**DEBRIS/ICE/TPS ASSESSMENT and
INTEGRATED PHOTOGRAPHIC ANALYSIS
OF SHUTTLE MISSION STS-110**

Armando Oliu
Process Engineering/Mechanical System Division/ET-SRB Branch,
Kennedy Space Center, Florida

April 8, 2002

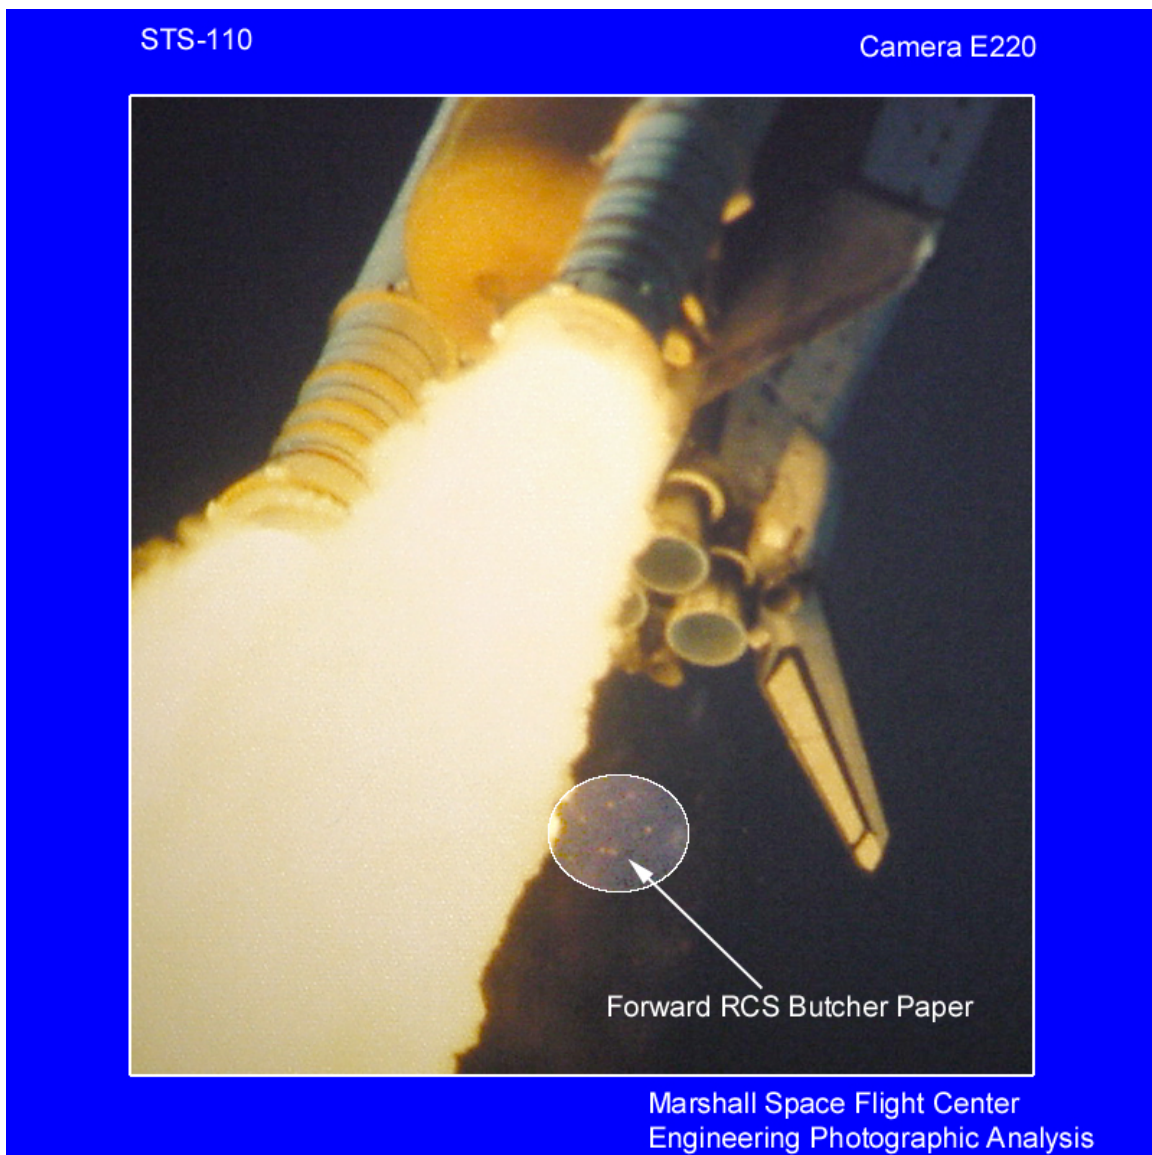
Figure 18. E220: RCS Butcher Paper Debris

Numerous pieces of forward RCS Butcher Paper were noted falling aft of the vehicle..

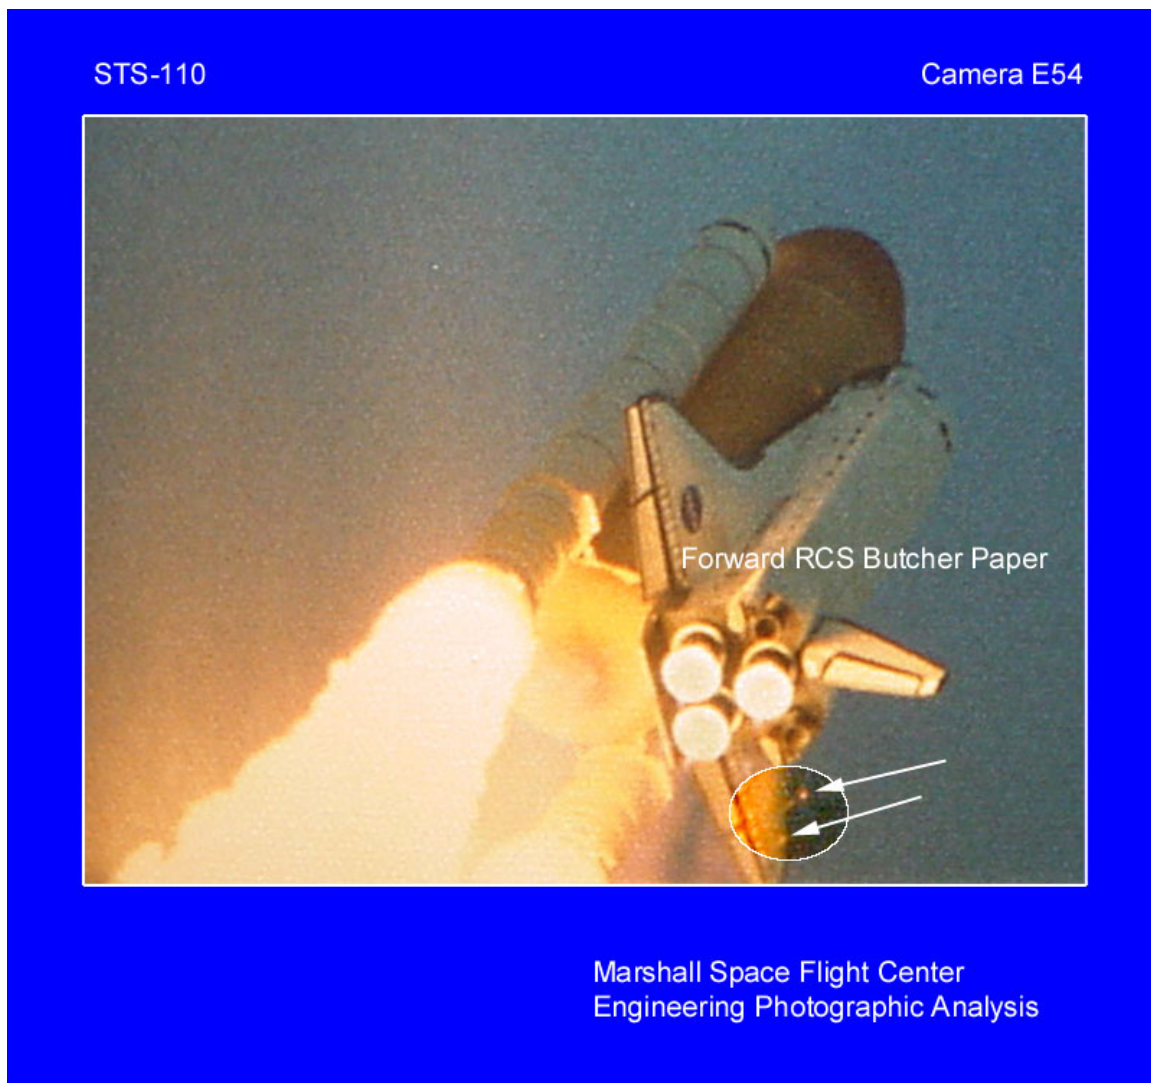
Figure 21. E54: RCS Butcher Paper Debris

Several pieces of Forward RCS Butcher Paper were observed falling over the +Y wing during ascent.

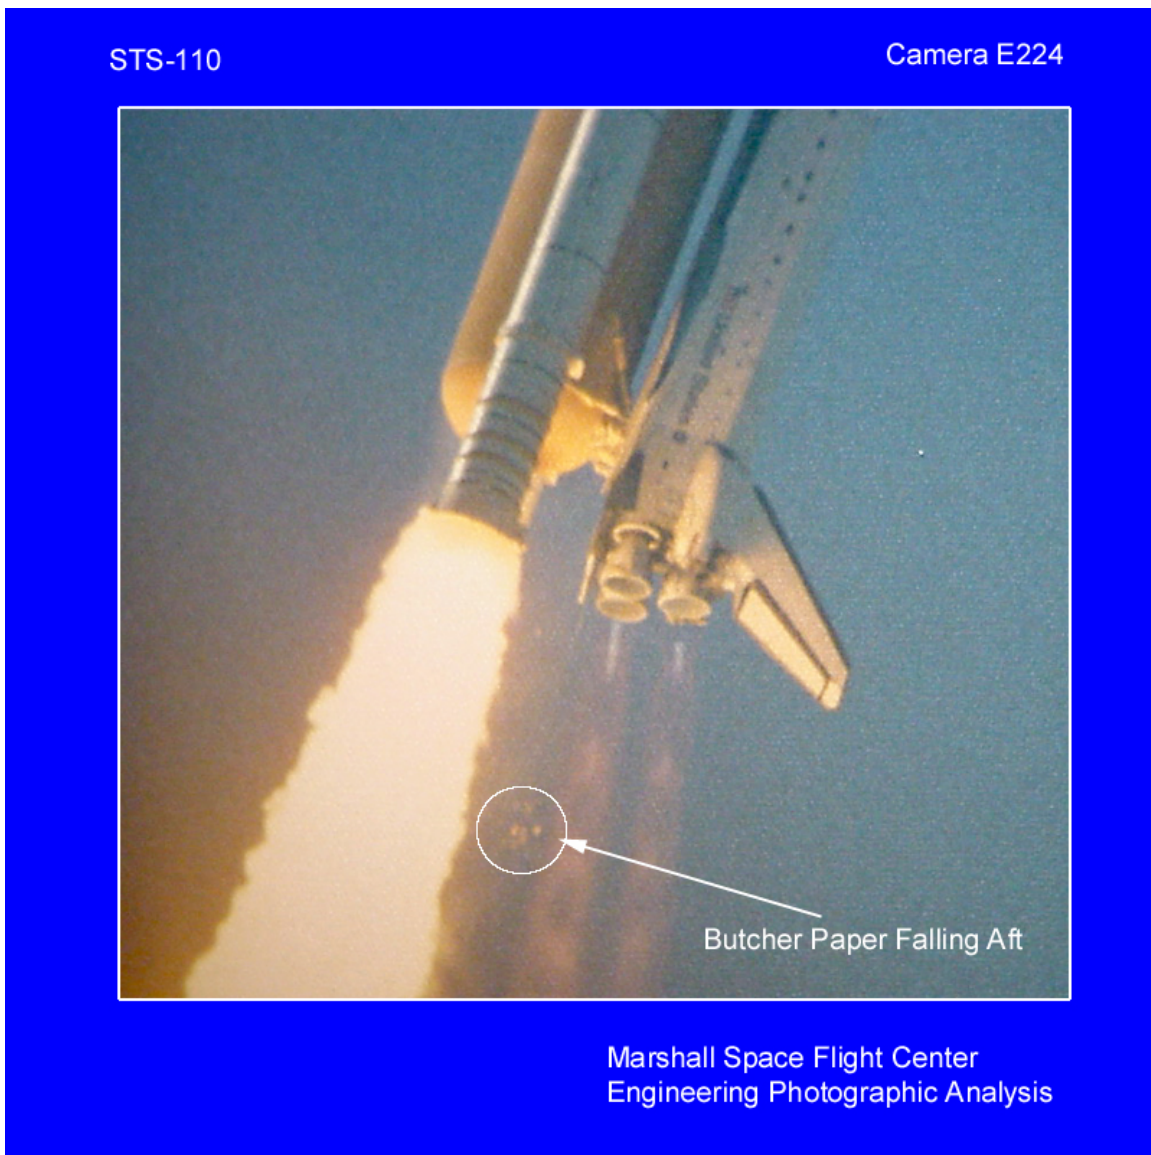
Figure 26. E224: Butch Paper Falling Aft

Numerous pieces of Butcher Paper were observed falling aft of the vehicle.

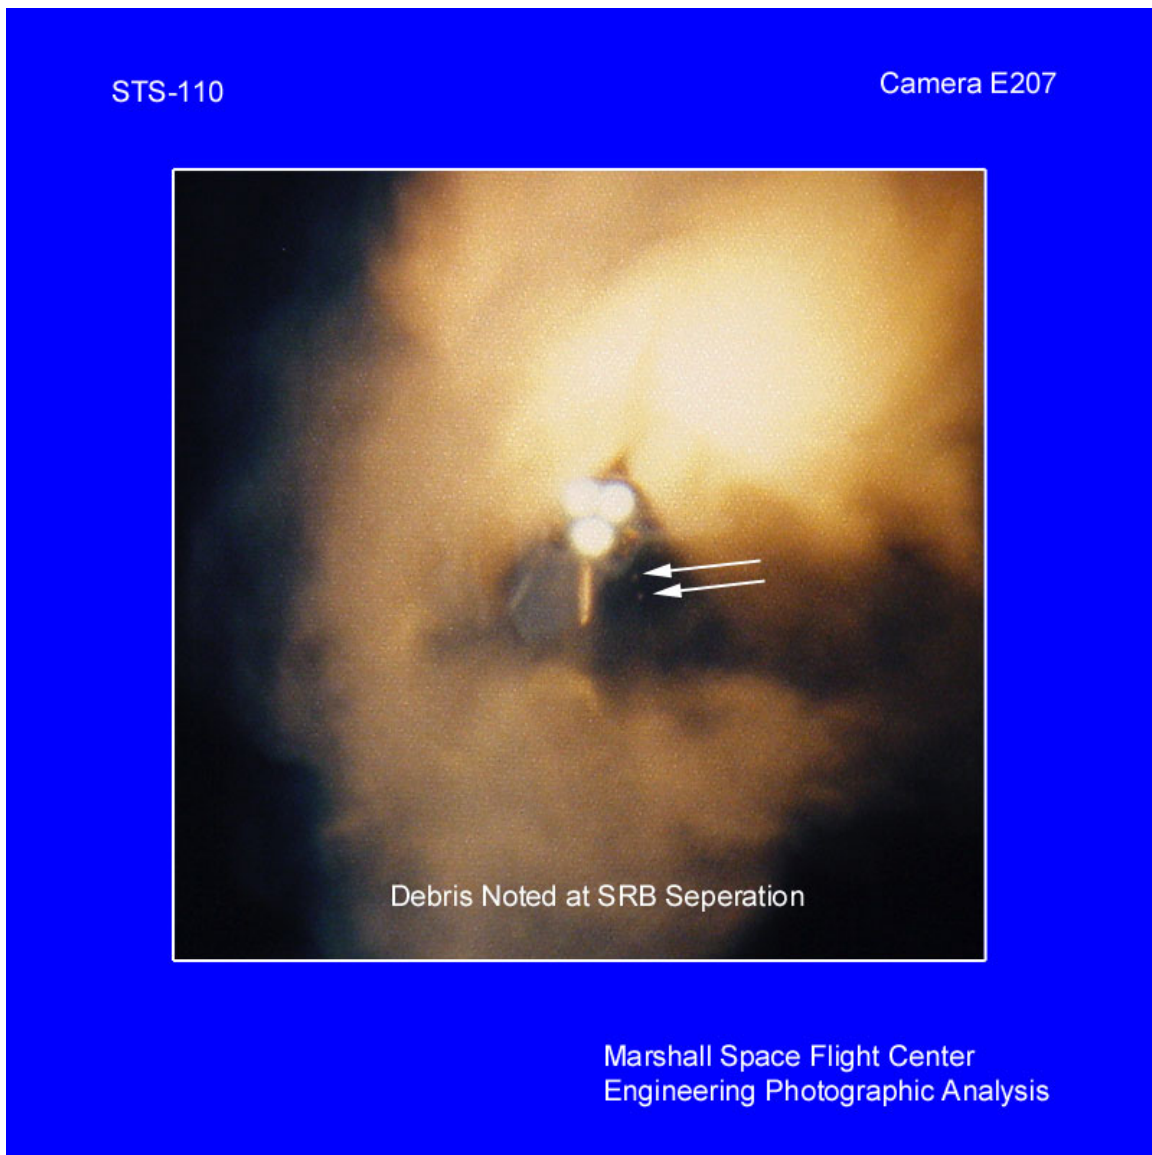
Figure 28. E207: Debris at SRB Separation

Debris material falling aft, over the -Y side of the vehicle wing, was observed during SRB separation.

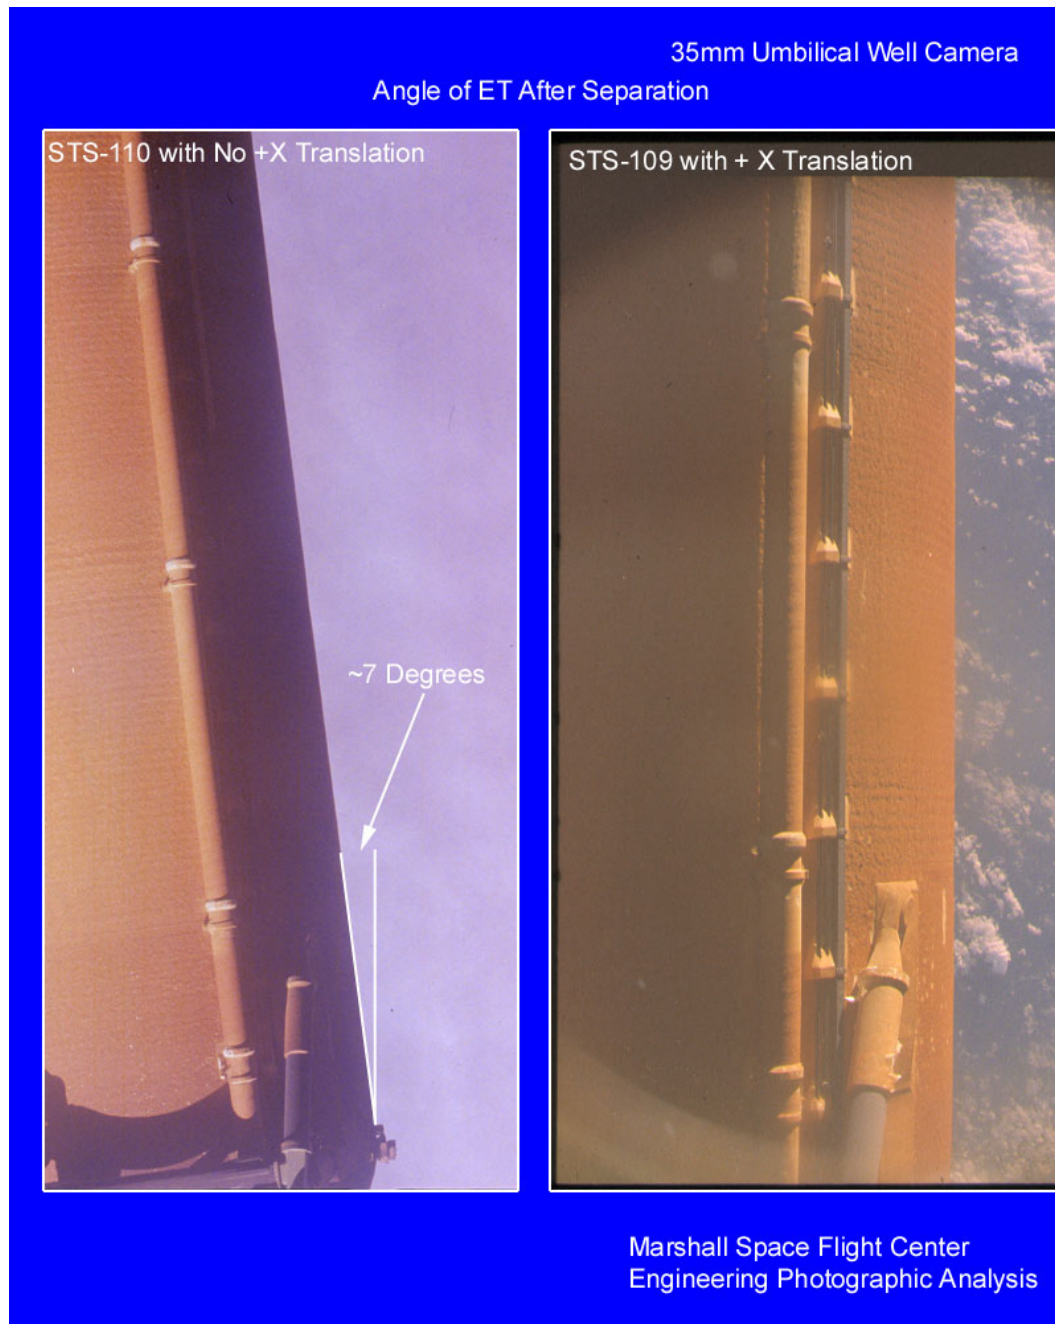
Figure 30. 35mm Umbilical Well Still Camera: ET/Orbiter Yaw Separation

Mr. Gregory Manich, Boeing, attributed this post-separation relative yaw as due to residual angular velocity from the OI-29 alpha-beta management maneuver. Mr. Manich notes that this is to be considered a nominal sequence of events and the same can be expected on any future flight and is within the scope of certification.

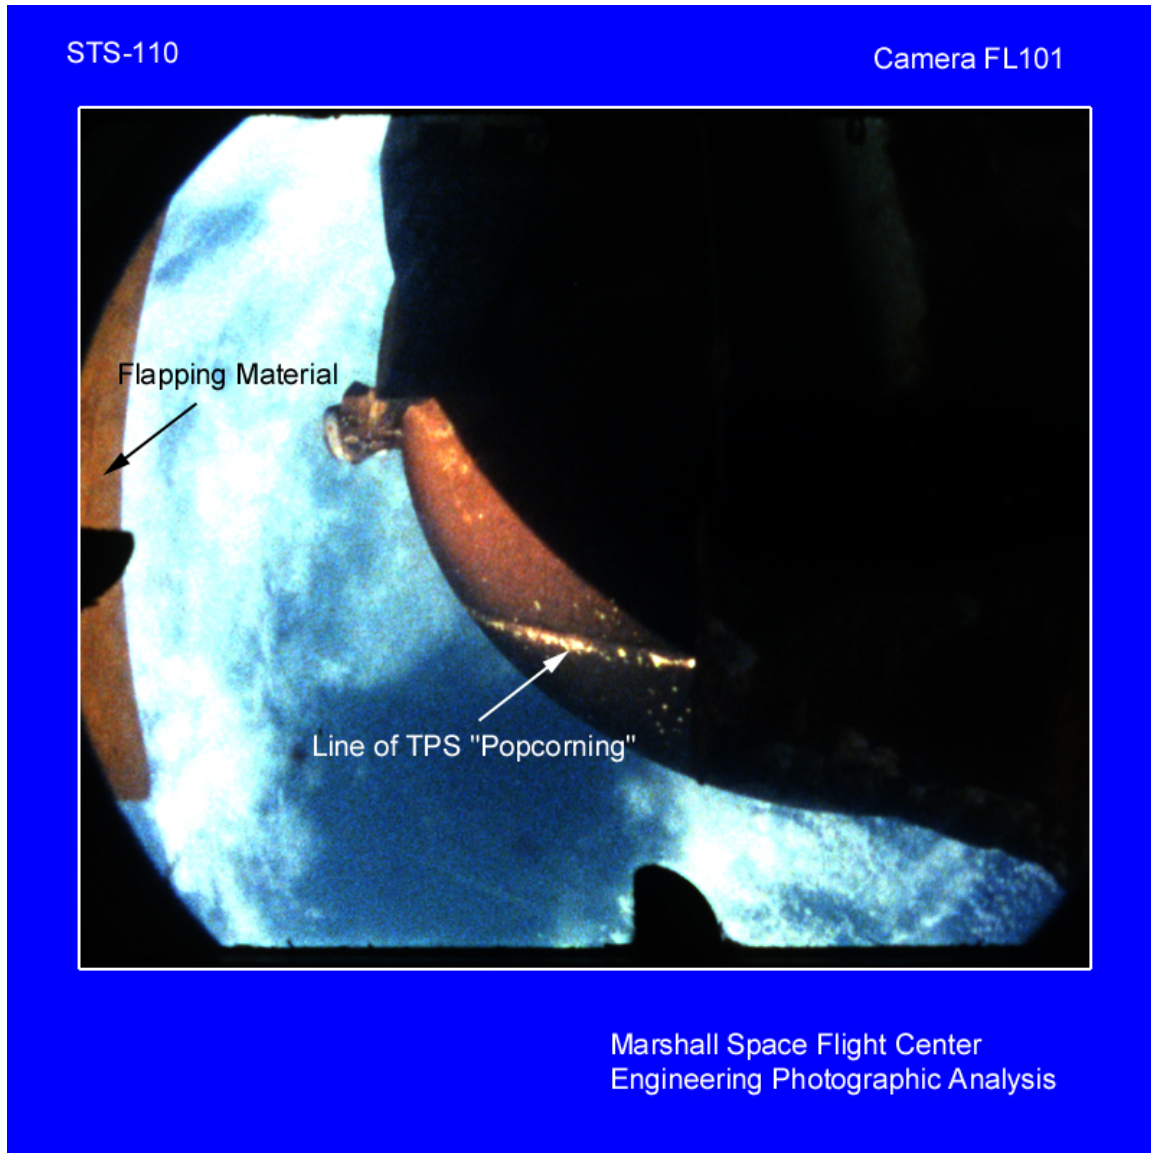
Figure 31. FL101: TPS “Popcorning” Line and Flapping Material on FL101 Port

An orange-brown colored, flapping material was observed attached to the Orbiter near the FL101 viewport prior to ET separation. This material was not observed after ET separation.

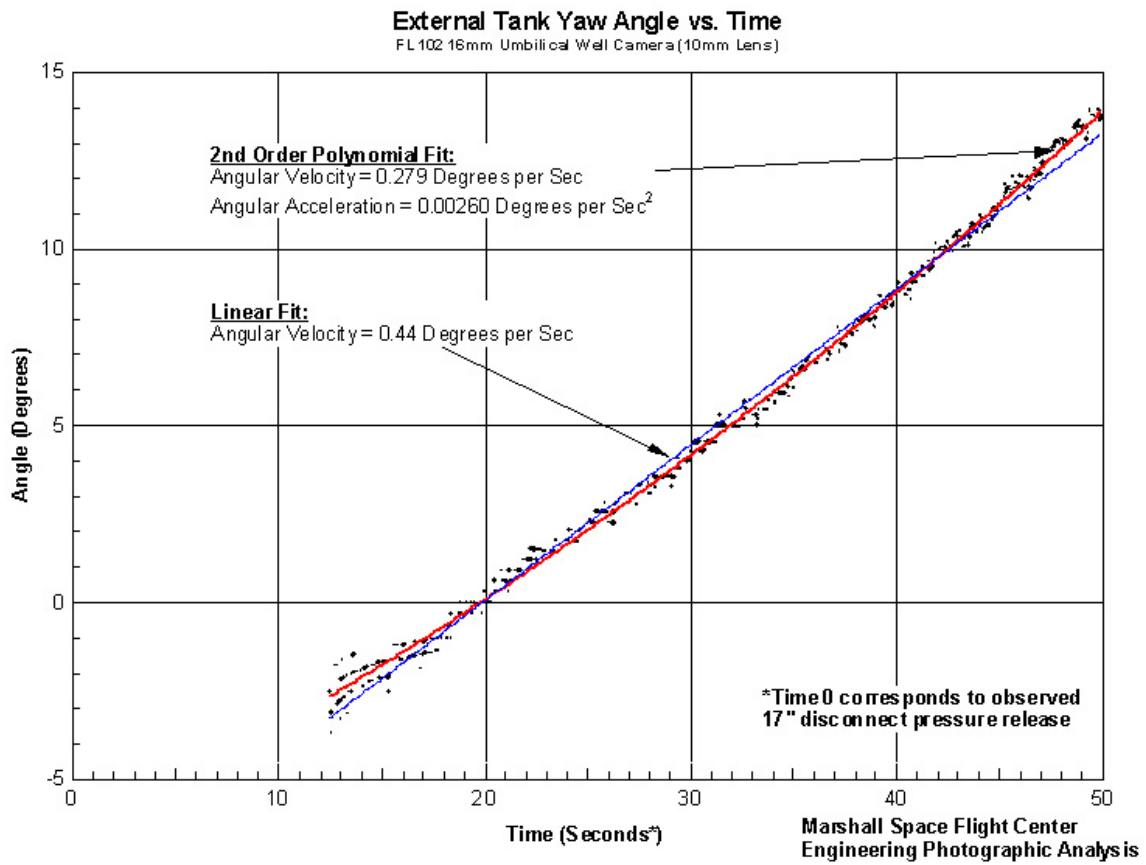
Figure 35. FL102 ET/Orbiter Yaw Separation Chart

Points from a sequence of nine hundred images from film camera FL102, spaced at 1/24 of a second (0.0417 sec) apart, were tracked. The 17-inch pressure disconnect event was determined to be about 298 frames prior to the frame where tracking points began. Using a linear approximation to the ET orientation, a yaw rate of 0.44 degrees/second was obtained, which agreed with the yaw rate from the 35mm Umbilical Still Camera images. A more physically appropriate second order curve fit for ET orientation was also performed with the FL102 data. The angular acceleration was calculated to be 0.0026 degrees/sec² and the angular velocity was calculated to be 0.279 degrees/sec, shown on associated FL102 camera chart.
